A Red Light Running (RLR) Photo Enforcement System was installed at the intersection of Des Plaines River Road at Balmoral Avenue on August 27, 2007 (northbound), after finding limited success with other attempted measures to promote safer driving and improve compliance with traffic laws. The following statistical analysis was performed through 2015. Calendar year 2016 was not included as the Illinois Department of Transportation (IDOT) has not yet completed collecting all data. The statistical analysis will be updated annually, as collected data becomes available from IDOT.

Des Plaines River Road at Balmoral Avenue **Rosemont, IL**

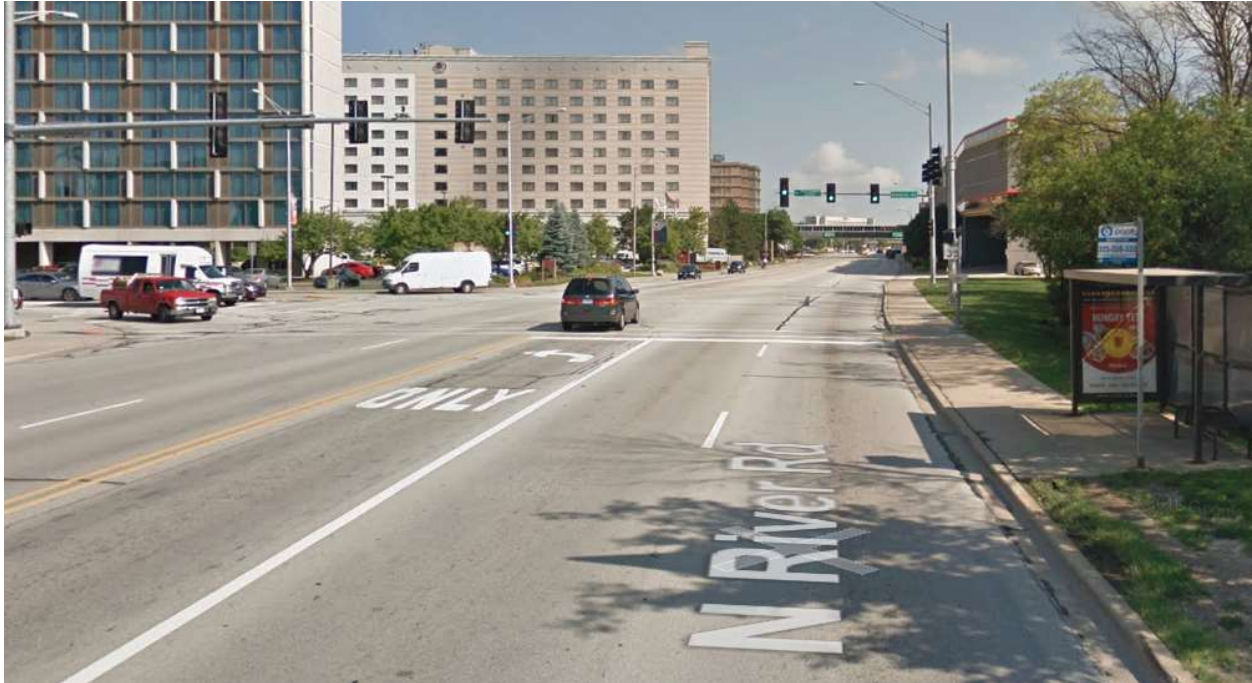
Des Plaines River Road at Balmoral Avenue - Northbound Approach

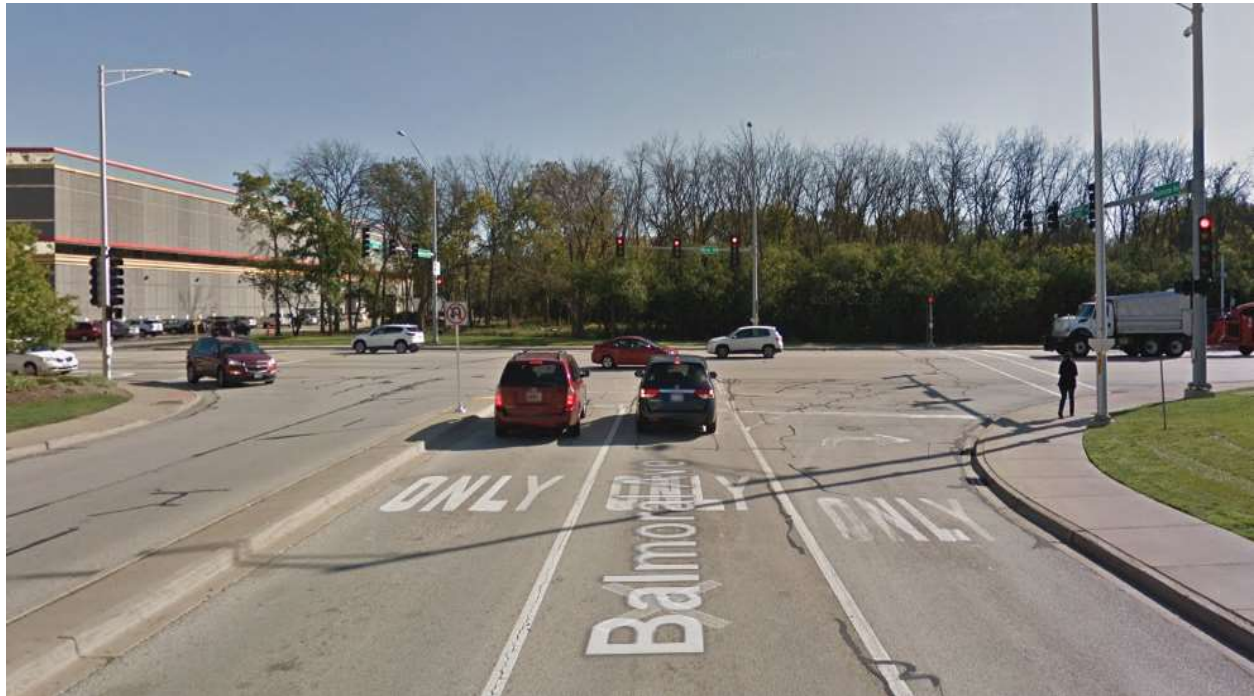
Des Plaines River Road at Balmoral Avenue - Eastbound Approach
